Construction Engineering
Research Laboratory

Structural Evaluation of Aircraft Hangar 46, Corpus Christi Army Depot

Ghassan K. Al-Chaar, Daniel J. Randolph,
Gregory E. Lamb, and Pramod J. Desai

February 2001

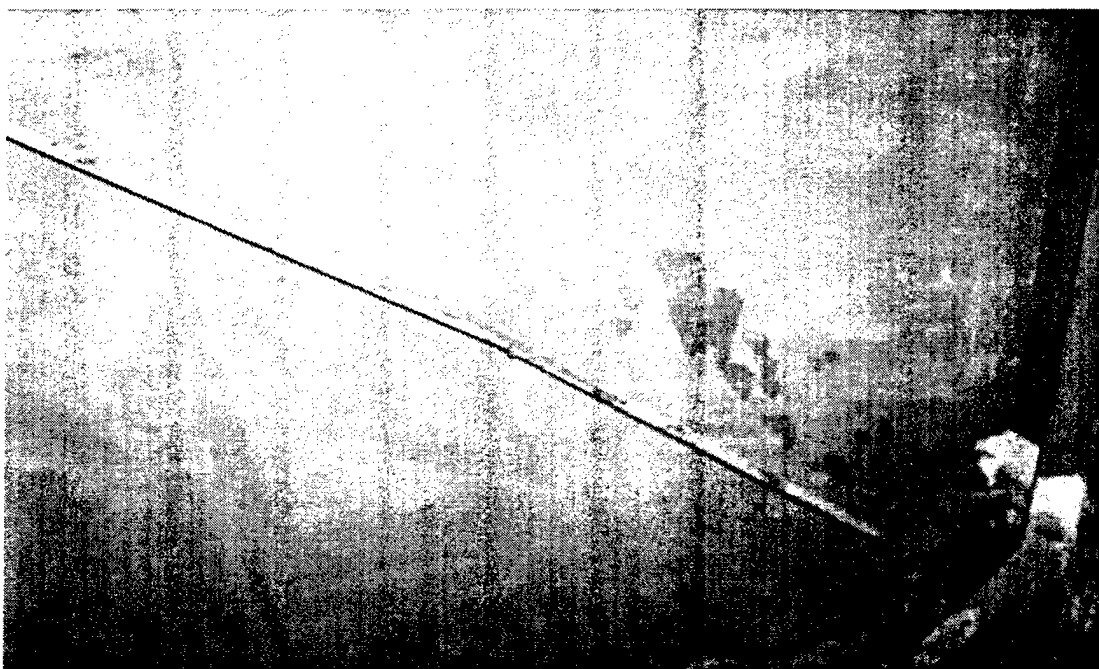
1. Tie rod (7/8 in. diameter) located at column P5.5, is bent. See Appendix A, Figure A-1.
2. Tie rods (7/8 in. diameter) located at columns P0.5, P1.5, P4.5, and P5.5 are loose.
3. Horizontal brace (10-I-21) located at second floor, between columns P5.5 and N5.5, is buckling. See Figure A-2.
4. Hangar door wheels are rusting and deteriorating. See Figure A-3.
5. Vertical members by handles on hangar doors are dented, likely resulting from opening doors with hooks and chains.
6. Concrete is spalling at column N5.5 (8-H-31). See Figure A-4.
7. Spalled concrete allowed major corrosion of column A0.5 (8-H-31), resulting in an estimated strength reduction of up to 30 percent. See Figure A-5.
8. Minor corrosion was found at the base of column AA0.5 (12-I-25).

Figure A-1. Buckled tie rod (7/8 in. diameter) near Column P5.5.

1. Replace the bent tie rod (7/8 in. diameter) attached to column P5.5 with identical or larger member that has the same connection details with same configuration of bolts and welds.

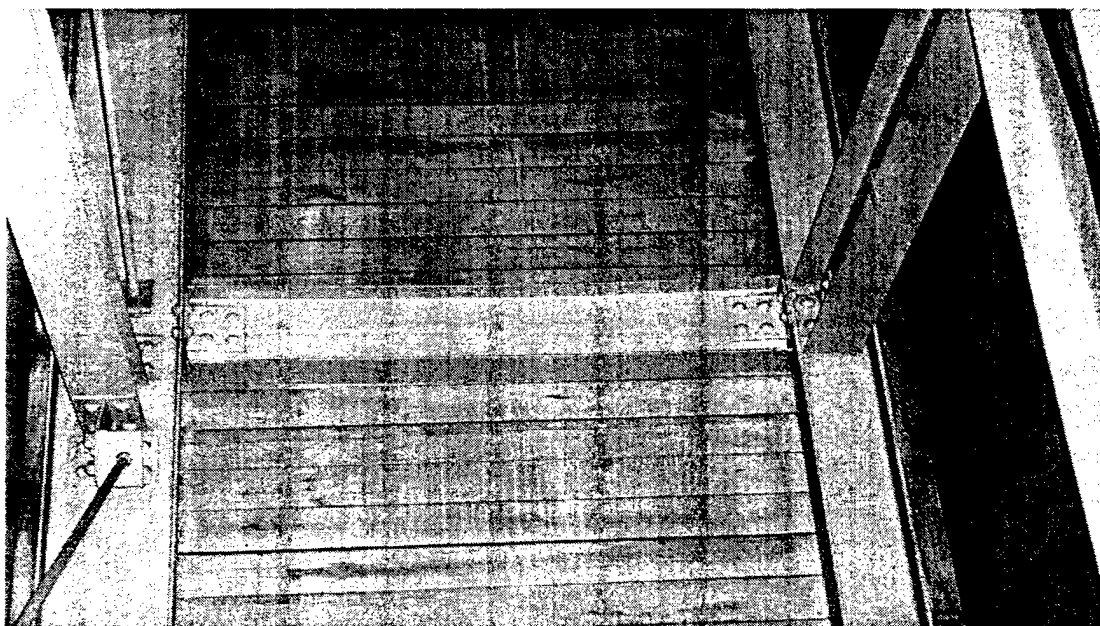
Figure A-2. Buckled horizontal brace (10-I-21), second floor between Columns P5.5 and N5.5.

2. Tighten or replace loose tie rods (7/8 in. diameter) attached to columns P0.5, P1.5, P4.5, P5.5.
3. The buckling horizontal brace (10-I-21) on the second floor, between columns P5.5, N5.5, is not designed for compression, but has been acting as a compression member. This brace is considered to be a secondary member. It would be possible to increase stiffness and strength through retrofit, but this would make connections more vulnerable to failure. Therefore, no retrofit is advised.

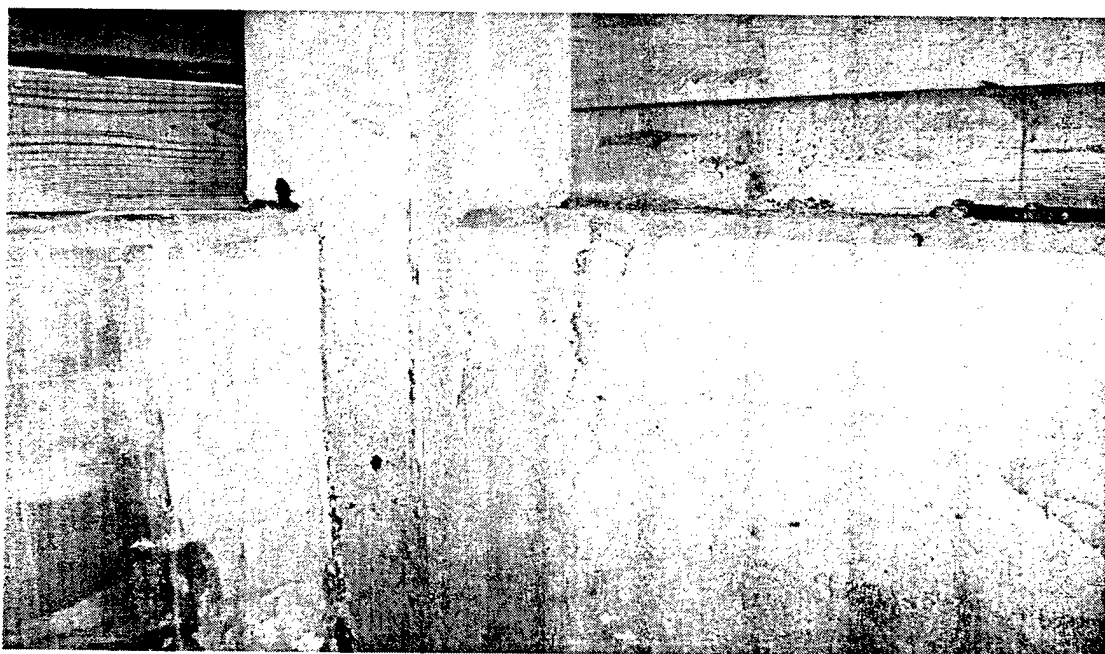
Figure A-4. Spalling concrete at the base of Column N5.5.

6. Remove spalling concrete from column N5.5 (8-H-31), sandblast rust off of the column structural steel, repair steel as shown in Figure D-4 of TR-99/27, and re-cast the concrete.

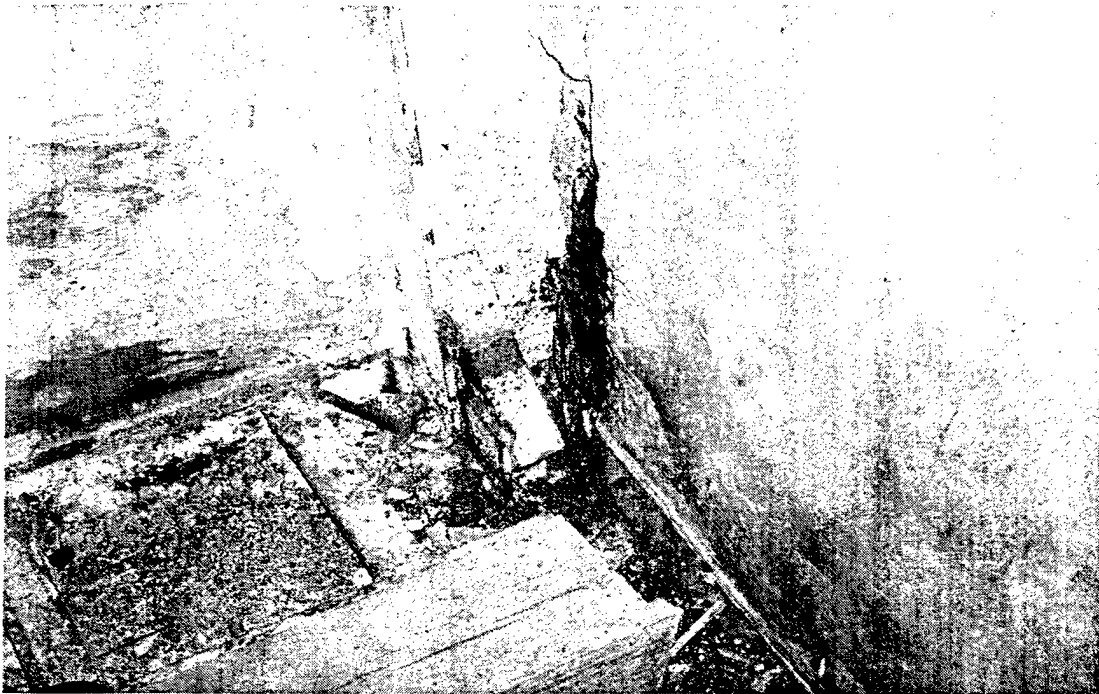
Figure A-5. Major corrosion sample retrieved from base of Column AO.5 (8-H-31).

7. Remove spalling concrete from column A0.5 (8-H-31), sandblast rust off of the column structural steel, repair steel as shown in Figure D-5 of TR-99/27, and re-cast the concrete.

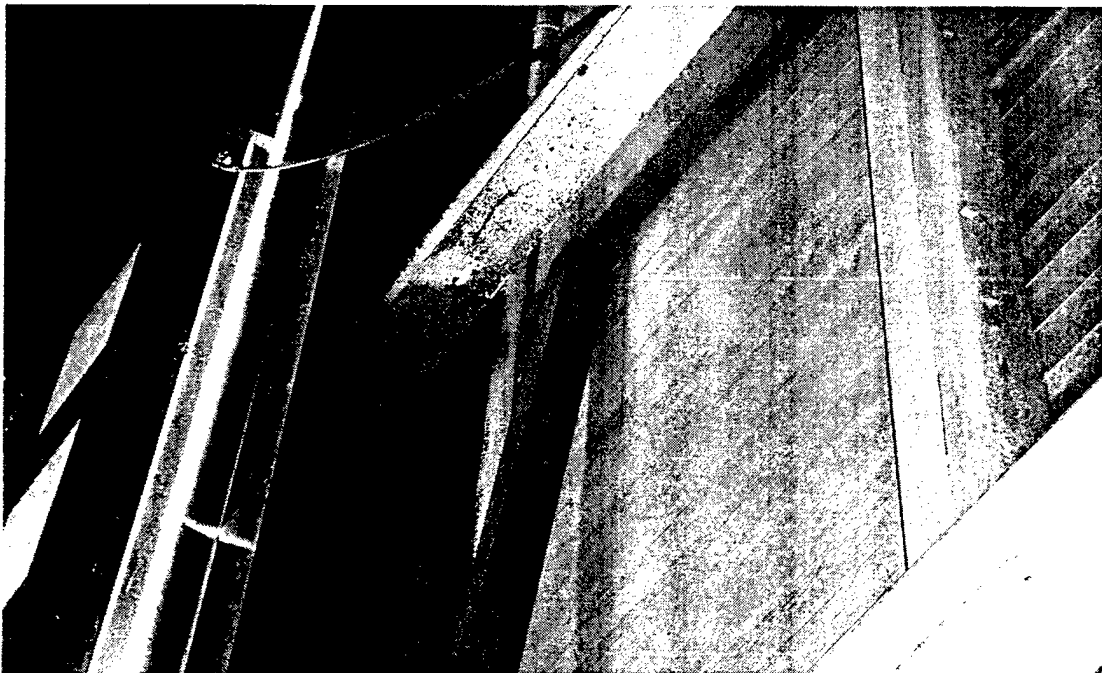
9. Unsupported wood column (4x4 post) near column AA2 is a safety hazard. See Figure A-6.
10. A makeshift wood column (4x4 post) near column AA2 provides inadequate support of second floor beam between columns AA2 and AA1.5. See Figure A-7.
11. A beam is under torsional stress at the second floor between columns AA4 and AA4.5 (6-H-15.5).
12. Major corrosion of the web and flange at the base of column A5 (18-I-47) has resulted in an estimated 30 percent strength reduction. See Figure A-8.
13. Minor corrosion of the web and flange at the base of column A5.5 (8-H-31) has resulted in an estimated 10 percent strength reduction. See Figure A-9.

Figure A-6. Loose timber near Column AA2.

8. If the base and anchorage of column AA0.5 (12-I-25) are sufficient, repair as shown in Figure D-4 of TR-99/27; if not, repair as shown in Figure D-5 of TR-99/27.
9. Remove unsupported wood column (4x4 post) at column AA2.
10. Remove makeshift wood column (4x4 post) near column AA2 or securely brace the column to the beams.
11. Retrofitting beam 6-H-15.5 on the second floor, to stiffen and strengthen it between columns AA4 and AA4.5, would make connections vulnerable to failure. Therefore, no retrofit is advised.
12. Repair column A5 (18-I-47) as shown in Figure D-5 of TR-99/27.
13. Repair column A5.5 (8-H-31) as shown in Figure D-5 of TR-99/27.

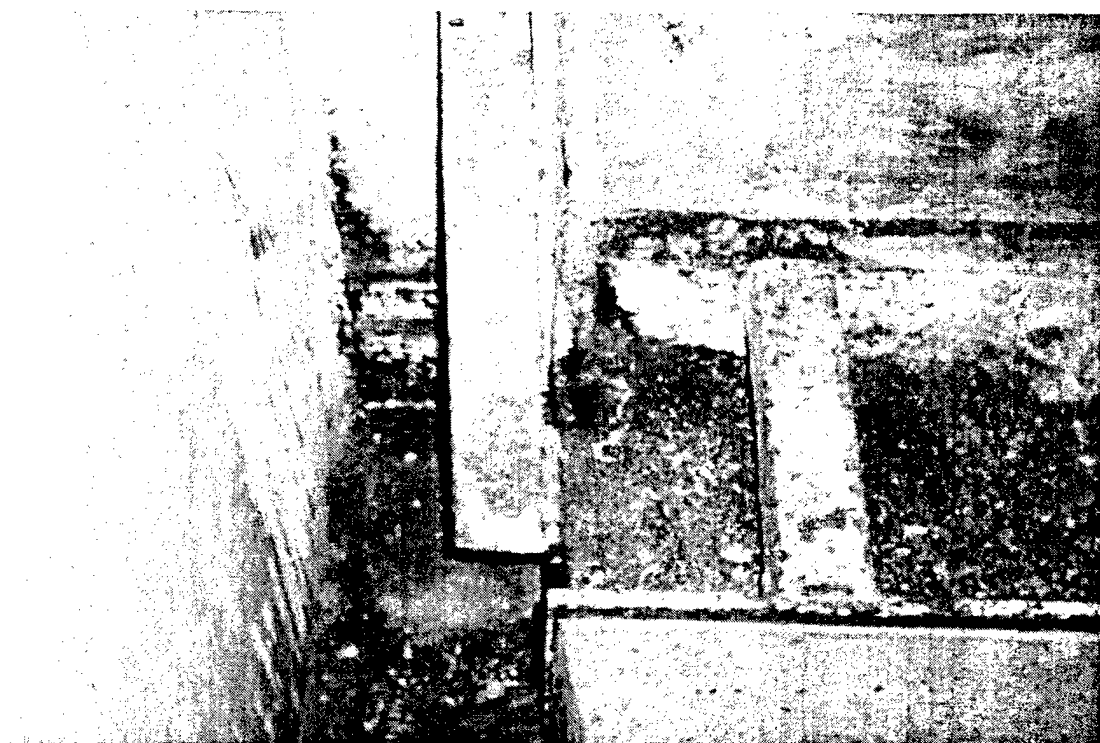
Figure A-9. Minor corrosion at the base of Column A5.5 (8-H-31).

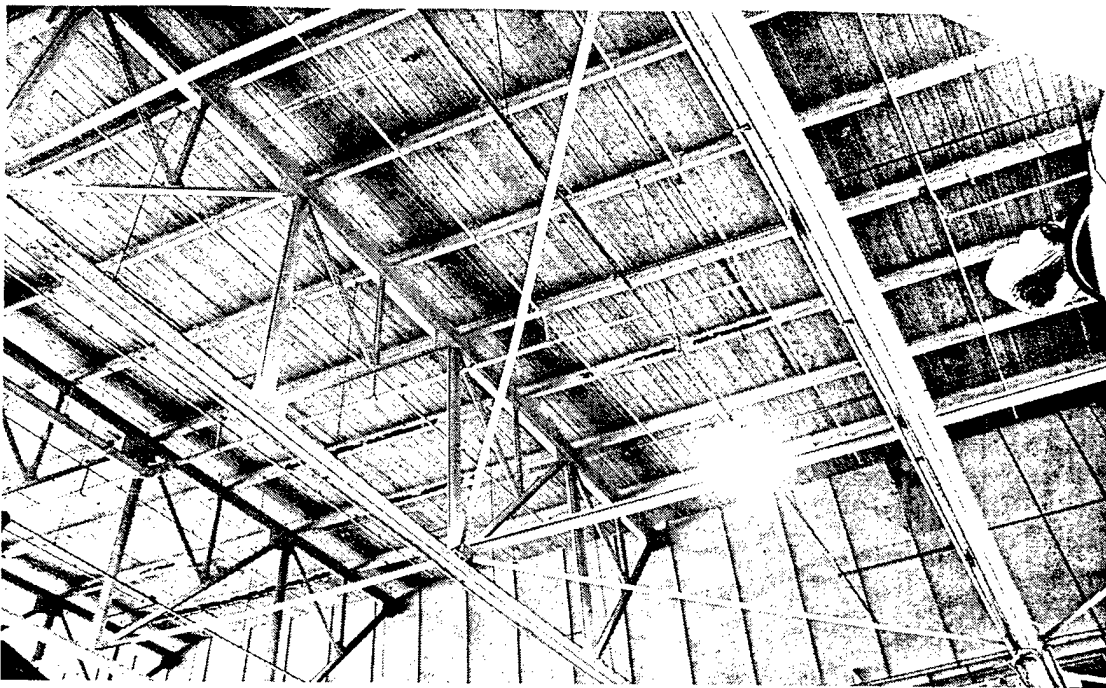
- between columns G2.4 and H2.5; see Figure A-11
 - between columns L2.5 and M3; see Figure A-12.
16. Buckling of bottom braces (single angle, $3\frac{1}{2} \times 2\frac{1}{2} \times \frac{1}{4}$) has occurred at the following locations:

Figure A-11. Buckled diagonal between Columns G2.4 and H2.5.

14. Any unpainted steel needs to be painted; use as listed in Figure D-1 of TR-99/27.
15. No retrofits are necessary for buckling bracing members listed in notes 15 and 16 of Chapter 2; these angles are intended for tension only.
16. No retrofit is necessary for column K2 (18-I-85), but further welding damage and gouging of the sort identified here should be avoided.

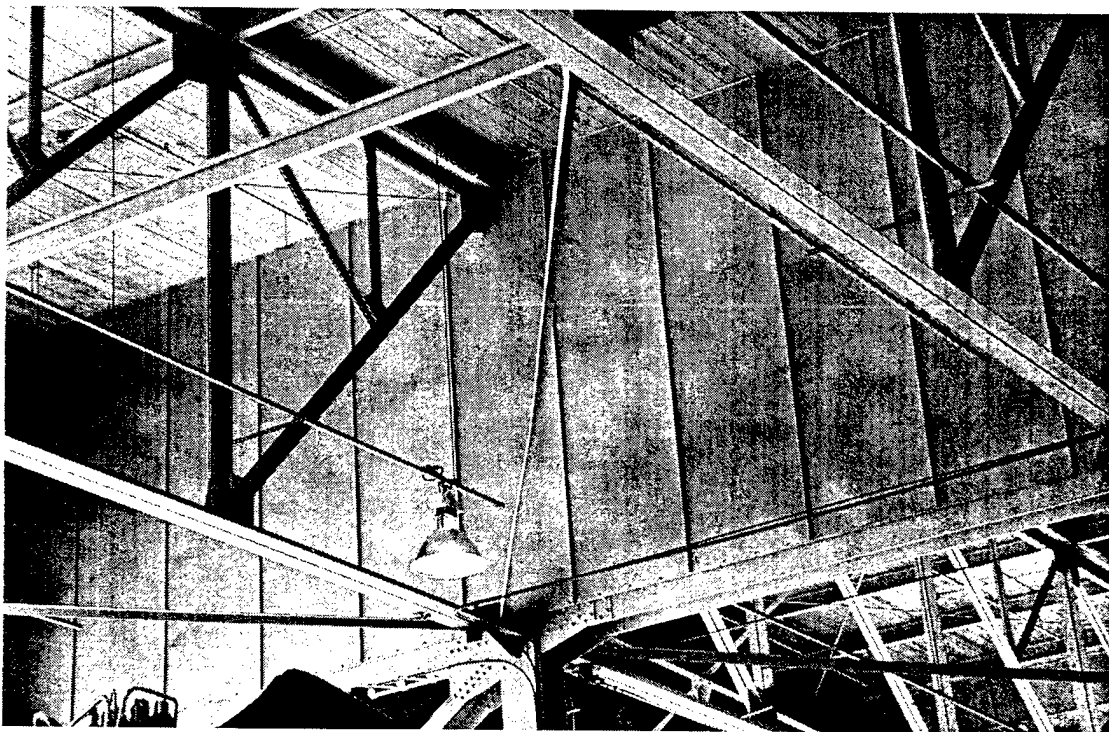
Figure A-12. Buckled diagonal between Columns L2.5 and M3.

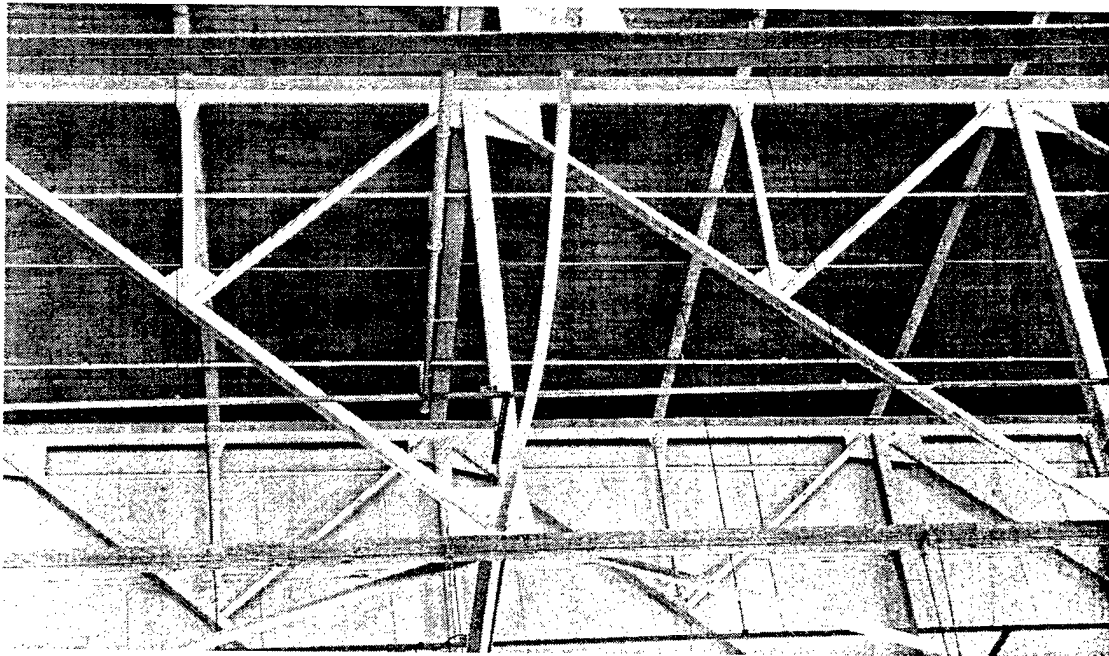
- between columns L2.4 and M2.4; see Figure A-13
 - between columns H2.5 and J2.5; see Figure A-14
 - between columns C2.5 and E2.5; see Figure A-15
 - between columns E3.1 and F3.1; see Figure A-16

Figure A-16. Buckled bottom chord between Columns E3.1 and F3.1.

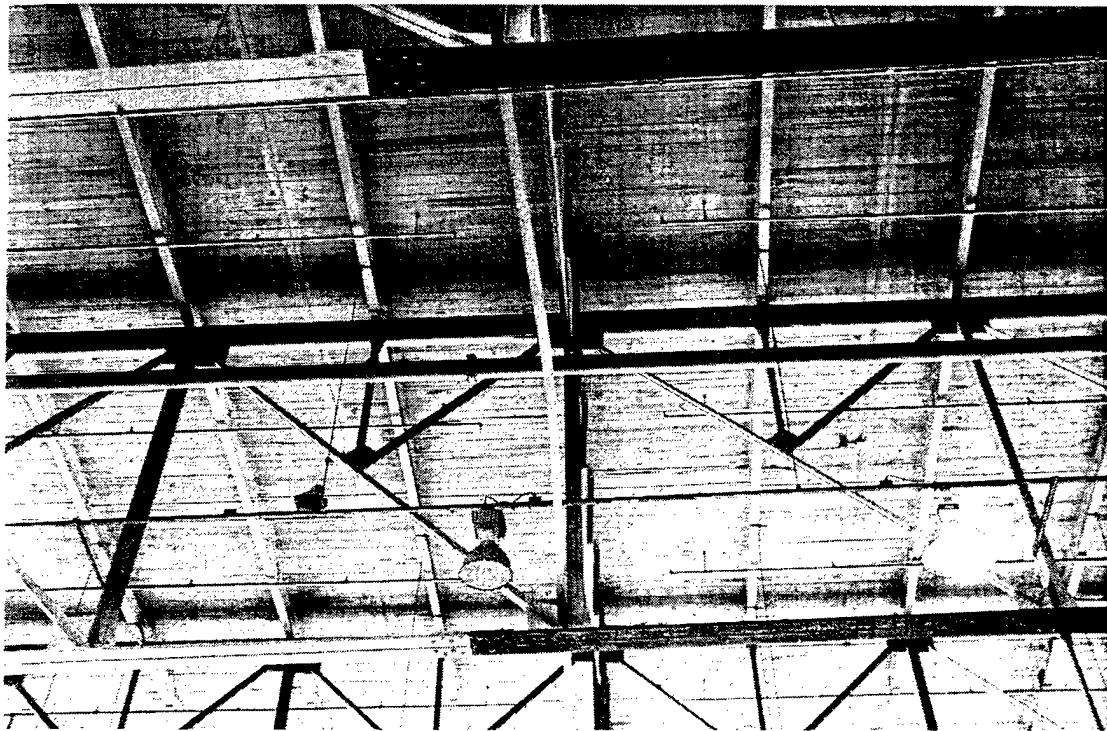
- between columns K3.1 and L3.1; see Figure A-17
 - between columns H3.2 and J3.2; see Figure A-18
 - between columns L3.4 and M3.4; see Figure A-19
 - between columns E3.4 and F3.4; see Figure A-20.

Figure A-18. Buckled bottom chord between Columns H3.2 and J3.2.
